**DEPARTMENT OF TRANSPORTATION**

Contract #: 04-0120F4Cty: SF/ALA Rte: 80 PM: 13.2/13.9File #: 99.28**WELDING INSPECTION REPORT****Resident Engineer:** Siegenthaler, Peter**Address:** 333 Burma Road**City:** Oakland, CA 94607**Report No:** WIR-020924**Date Inspected:** 20-Feb-2011**Project Name:** SAS Superstructure**OSM Arrival Time:** 700**Prime Contractor:** American Bridge/Fluor Enterprises, a JV**OSM Departure Time:** 1900**Contractor:** Zhenhua Port Machinery Company, Ltd (ZPMC) Chanxing Island**Location:** Shanghai, China**CWI Name:** Mr. ZHU ZHONG HAI**CWI Present:** Yes No**Inspected CWI report:** Yes No N/A**Rod Oven in Use:** Yes No N/A**Electrode to specification:** Yes No N/A**Weld Procedures Followed:** Yes No N/A**Qualified Welders:** Yes No N/A**Verified Joint Fit-up:** Yes No N/A**Approved Drawings:** Yes No N/A**Approved WPS:** Yes No N/A**Delayed / Cancelled:** Yes No N/A**Bridge No:** 34-0006**Component:** OBG Segment**Summary of Items Observed:**

## WELDING INSPECTION REPORT

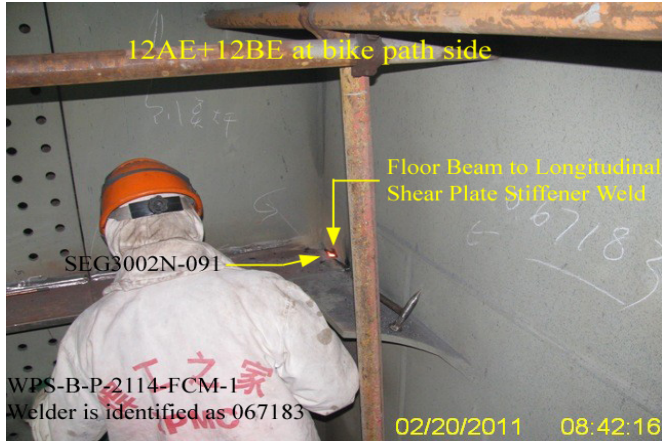
ZPMC welding personnel performing Shielded Metal Arc Welding of Fillet welds joining the floor beam to longitudinal shear plate stiffener weld joint located on 12AE+12BE at bike path side. The weld is designated as SEG3002N-091. The welder is identified as 067183. ZPMC QC Mr. WANG LI YANG was onsite monitoring the welding variables. The inprocess Shielded Metal Arc Welding appears to be progressing in compliance with WPS-B-P-2114-FCM-1. Further weld detail mention in attached picture.
